Yuułu?ił?atḥ

2019 ANNUAL WATER QUALITY REPORT

COMPILED BY: JEREMY VALENTINE - CHIEF OPERATOR YUUŁU?IŁ?ATH GOVERNMENT

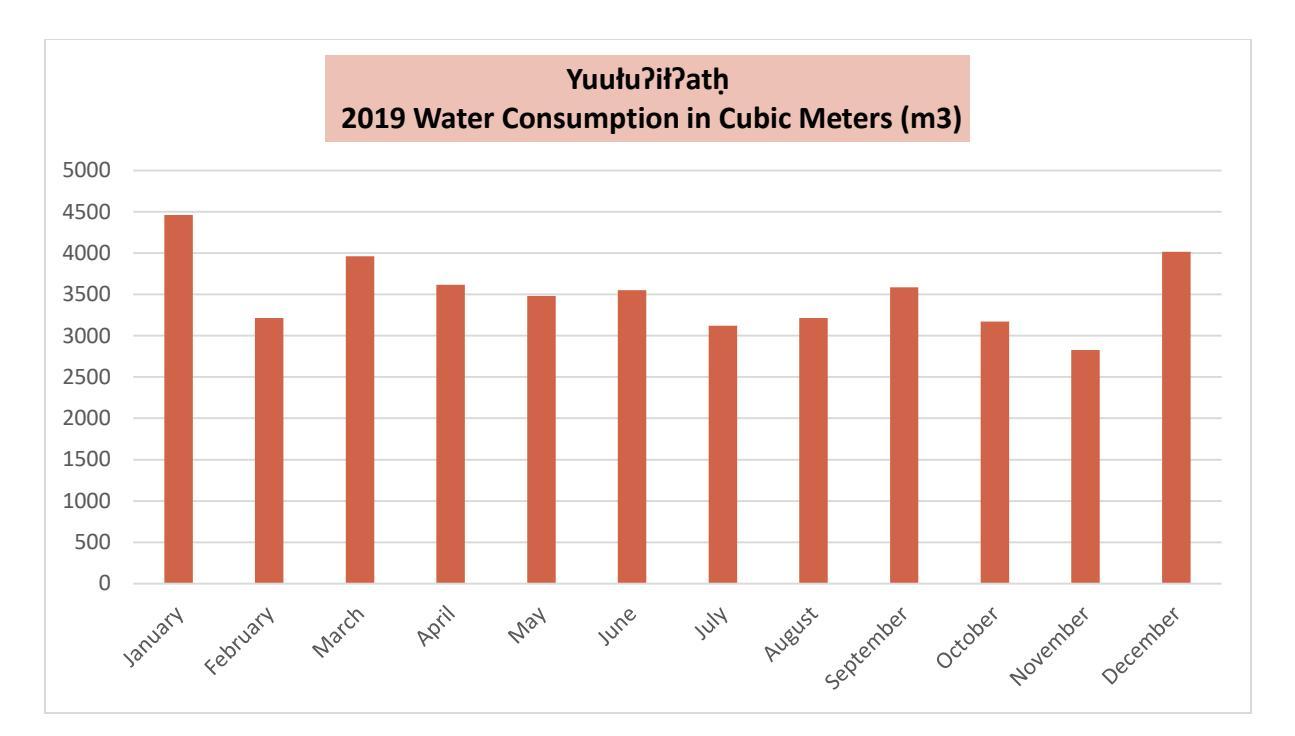
Yuułu?ił?ath consumed 42,119.3 m³ during from Jan2019 – end of Dec 2019.

This equates to an average of $3510m^3$ / month, and $117m^3$ / day.

During 2019 we had two water emergencies that used a lot of water and has skewed the total flow and averages slightly.

During January 2019 there was a water main break while an infrastructure assessment was being conducted. And during December 2019 there was a house fire that used a lot of water to contain.

We also conducted hydrant flushing in March 2019 and Hydrant teardown/maintenance in April 2019 which shows increased consumption.
